KYLES OF BUTE

Following a survey completed for Clydeport plc in May 2001, the Hydrographic Office has published (in January 2003) a revised chart no 1906, Kyles of Bute, and the inset from that is reproduced below.

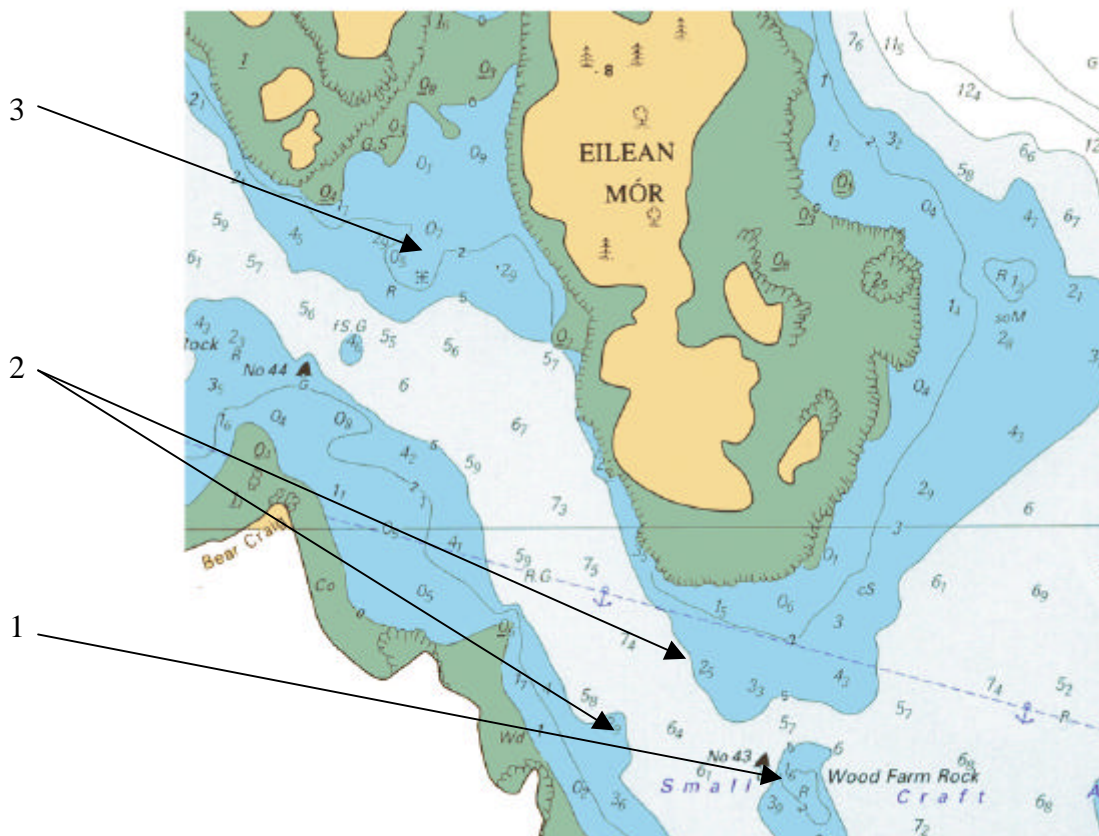
1. the flood stream starts to set south-easterly before LW, and so the Wood Farm Rock buoy (no 43, green conical) is understood to lie at that time very close indeed to the rock which it marks. As indicated in the CCC Sailing Directions, yachts should aim to pass close **BUT NOT TOO CLOSE**, to this buoy particularly at or near LW.

2. for yachts drawing 2 metres or more, it should be noted that there are two relatively shallow patches approximately 60 metres NW and 100 metres WNW of buoy no 43. There is an easy passage between these, but once again the CCC Sailing Directions should be heeded – “close but not too close” to buoy no 43.

3. the rock less than 100 metres NE of buoy no 44 has been re-plotted as somewhat larger than in previous editions of this chart. **THIS ROCK IS A SERIOUS HAZARD, AND YACHTS BEATING THROUGH THE SOUTH CHANNEL SHOULD TAKE PARTICULAR CARE.**

4. all other hazards should be noted, and due care taken in navigating this channel.
